## Update "With-Site-Visit" Reserve Study

### **Westcliff Spokane, WA**

**Report #: 21809-3**  
**For Period Beginning: January 1, 2021**  
**Expires: December 31, 2021**

**Date Prepared: May 14, 2020**

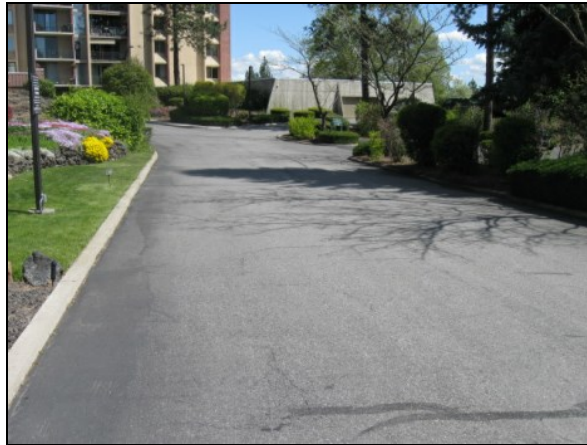
Keeping water from entering into the base is key to minimizing damage and deterioration. We recommend having surfaces sealed and repaired as directed in component #121; regular cycles of seal coating are recommended for maximum design life. As routine maintenance, keep roadway clean, free of debris and well drained; fill/seal cracks to prevent water from penetrating into the sub-base and accelerating damage. Even with ordinary care and maintenance, plan for eventual large scale resurface (overlay) at roughly the time frame below. As timing draws nearer, consult with asphalt vendor/consultant for specific recommendations and complete scope.

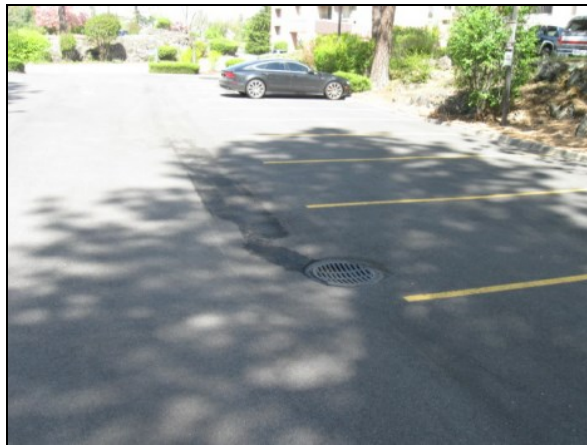
Comments: Generally good, stable condition noted. Inspect regularly, clean and repair cracks promptly each year as routine maintenance. Seal coat for maximum protection and service life - see next component.

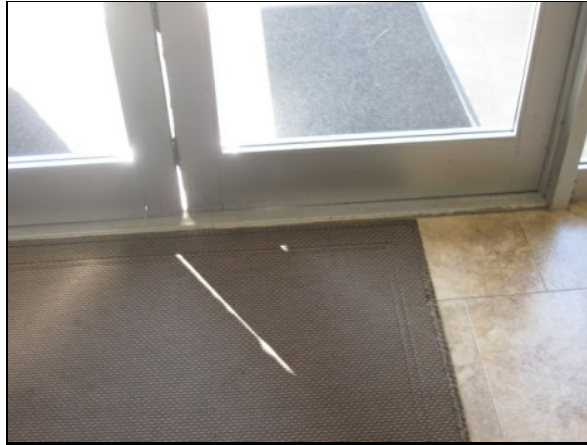
Comments: Good condition of tile. Entry walk-off mat fair. Be sure to seal the tile and grout regularly as routine maintenance. Twenty year replacement cycles factored below.

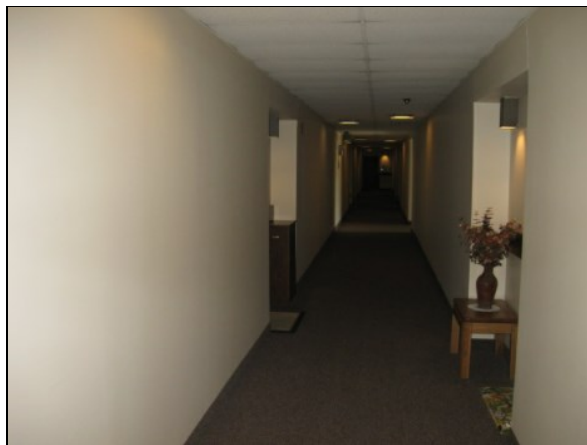
Comments: Painted surfaces were noted to be in generally fair condition. Regular cycles of professional painting are recommended to maintain appearance; best timed prior to carpet replacement (component #705). Keep touchup paint on site for in between cycle maintenance projects. Note: acoustical ceiling tile may need replacement at some point as it will tend to crack and discolor over time - typically in the \$2 -3 / sf range. - not factored below.
