## Update "With-Site-Visit" Reserve Study

### **Westcliff Spokane, WA**

**Report #: 21809-3**  
**For Period Beginning: January 1, 2021**  
**Expires: December 31, 2021**

**Date Prepared: May 14, 2020**

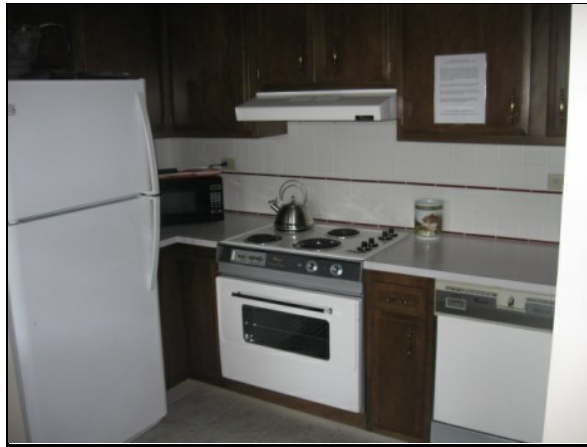
Comments: No damage or unusual wear noted. As routine maintenance, inspect regularly, perform any needed local repairs promptly utilizing general operating funds. Seal tile for best protection.

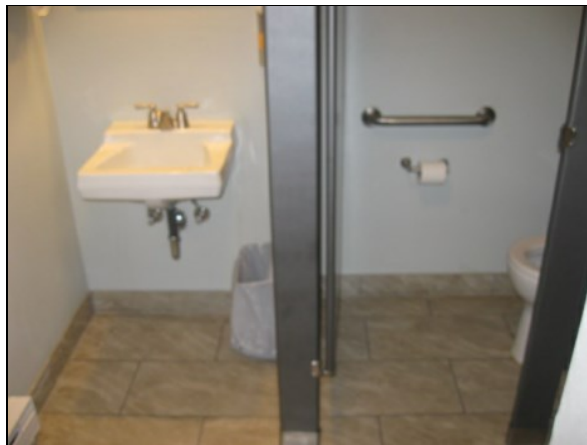
Comments: Assumed to be in functional condition. New baseboards reportedly installed at time of wallpaper in elevator lobbies. No predictable expectation to replace these all at once - replace individually or at time of periodic common area renovations. No separate reserve funding suggested.

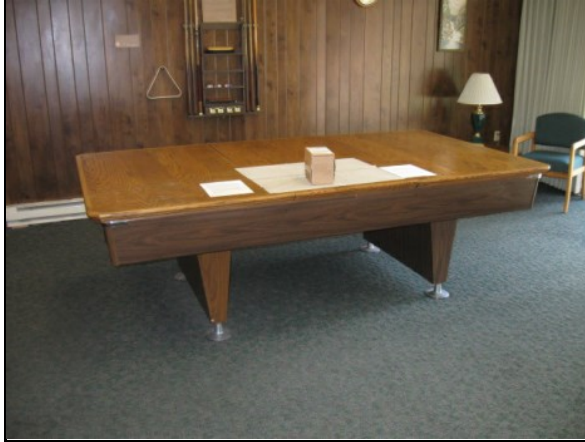
Comments: Fair, functional condition of furniture/furnishings. We assume that periodic small purchases of individual pieces or donations will maintain function in these areas. No reserve funding suggested. See component 713 for window treatments (hallways).

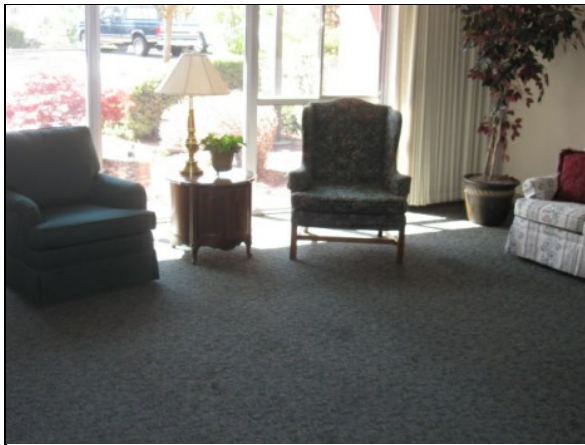
Comments: We did not inspect interior. No stated desire or need per board for interior improvements at this time - funding allowance extended three years. We recommend setting aside a general funding allowance for periodic professional refurbishing which may include item such as flooring, painting, replacement of appliances, furniture, window treatments, lighting, water heater, bathroom fixtures, etc..., to maintain marketability and function.

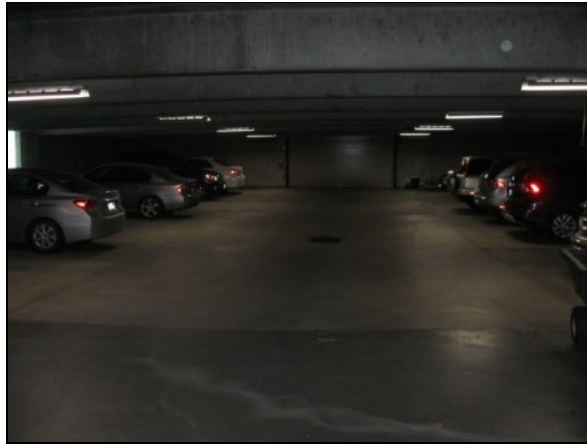
**Comp #: 600 Garage - Maintain/Repair****Quantity: ~ 23,000 GSF**

Comments: Concrete parking garage appeared in generally good condition with no significant cracking, settling or other deterioration observed. Some localized efflorescence was observed. Efflorescence is a white colored powder. It typically is a sign that water has previously penetrated through the concrete. As water makes it way through the concrete, it dissolves the salts and other minerals within the concrete, into the water. When the water reaches the interior surface it evaporates, which leaves the minerals behind in powder form. Efflorescence can occur during the construction process while the concrete is hardening, or it can occur from a water leaking into the garage.

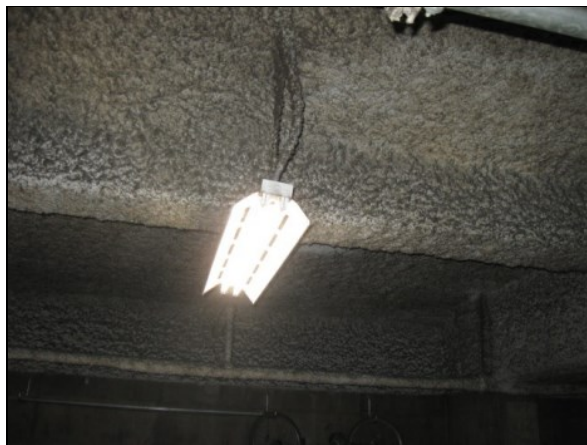
**Comp #: 615 Garage Lighting - Repair/Replace****Quantity: ~(44) light fixtures**

Comments: Garage lights were ceiling mount florescent fixtures. Usage of LED bulbs mentioned. At the time of our 2011 inspection, newer bulbs and ballasts reported. Inspect periodically and repair as needed to maintain proper lighting levels. Change bulbs as needed. No expectation of a large scale replacement. Replace as needed using operation and maintenance funds. No reserve funding suggested.

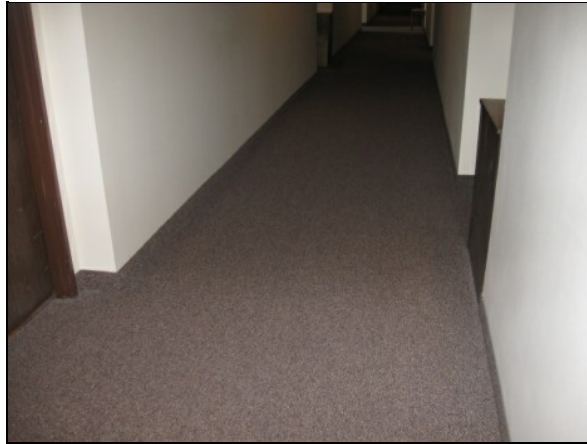
**Comp #: 705 Hallway Carpeting - Replace****Quantity: ~ 513 square yards**

Comments: Generally fair condition, with no significant wear patterns, soiling, damage, etc... Expect higher traffic such as elevator lobbies to show higher wear and deterioration (see next component for elevator lobbies).

As part of ongoing maintenance program, professionally clean as needed. Plan to replace at the time frame below, best timed after repainting (component #710). Wide variety of type and quality available; funding allowance factored below based upon client estimate.

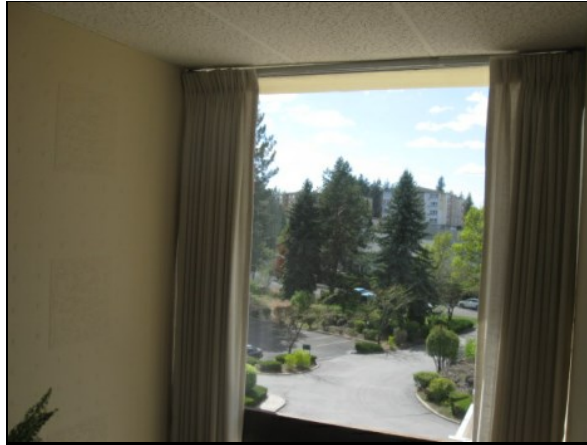
**Comp #: 713 Window Treatments - Replace****Quantity: (7) drapery sets**

Comments: Draperies were reportedly cleaned, and deemed to be in satisfactory condition. Replacement cycles extended to align with elevator lobby flooring for color coordination.
